The Oroville Dam 2017 Spillway Incident

And Lessons from the Feather River Basin

September
2017

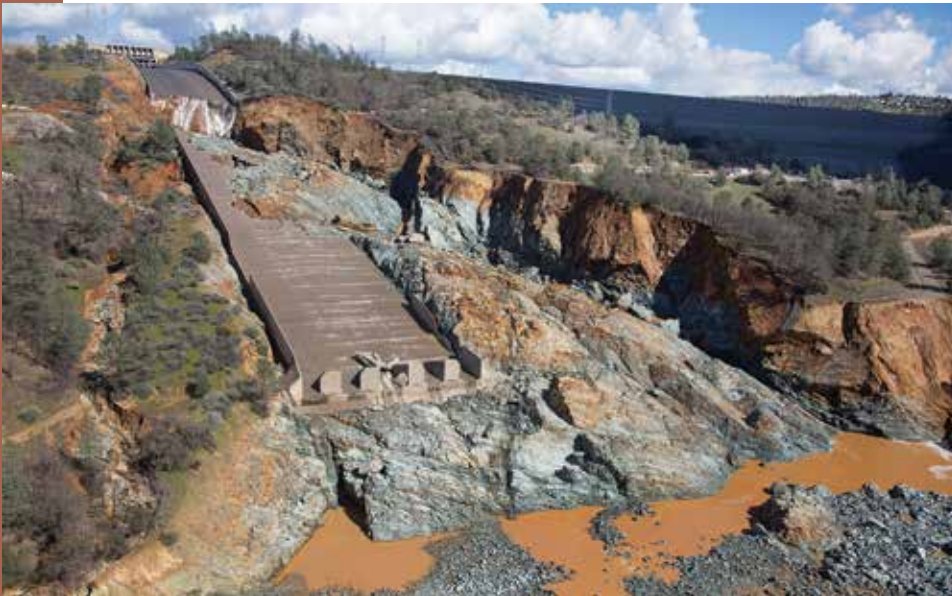
Oroville Dam Spillway, Feb. 27, 2017. The Oroville dam main spillway after spill flow releases ceased for repair inspections. Oroville Dam is in the shadow on the upper right. *Source: Dale Kolke, CA Dept. of Water Resources (hereby DWR).*

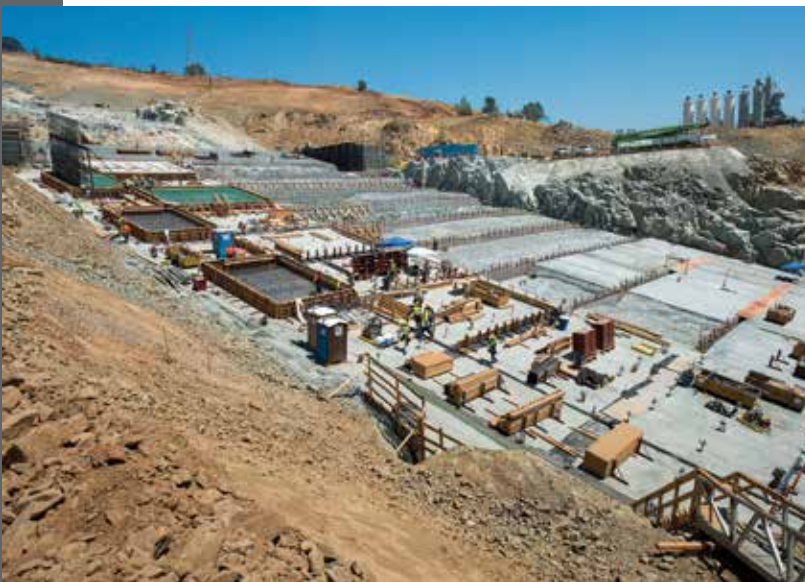
Oroville Dam Main Spillway Repair. Image date: August 9, 2017.
Source: Florence Low, DWR.

By late spring, the reconstruction began in earnest, with the goal of reconstructing the lower main spillway and its foundations and making smaller repairs to the upper spillway during the 2017 construction season. The plan for the emergency spillway is to build a cutoff wall by November 1 that would be located downhill on the hilltop to prevent headcutting, if used. At a later time, the spillway lip would receive a roller-compacted-concrete buttress and a “splash pad” (or “apron”).⁶³ Transmission towers and powerlines are being relocated out of harm’s way.⁶⁴

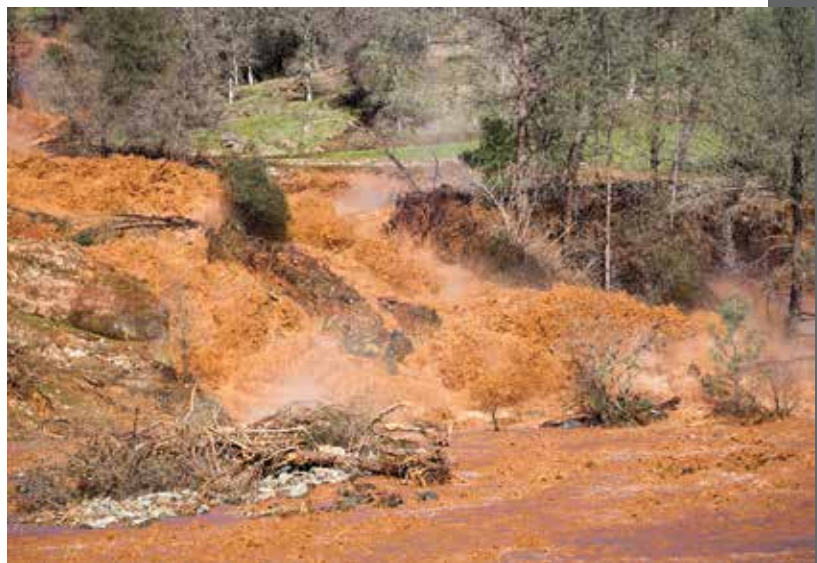
Oroville Dam Spillway Erosion, Feb. 11, 2017. Water and debris from the emergency spillway failure flow into the diversion pool just downstream of the dam. *Source: Dale Kolke, DWR.*

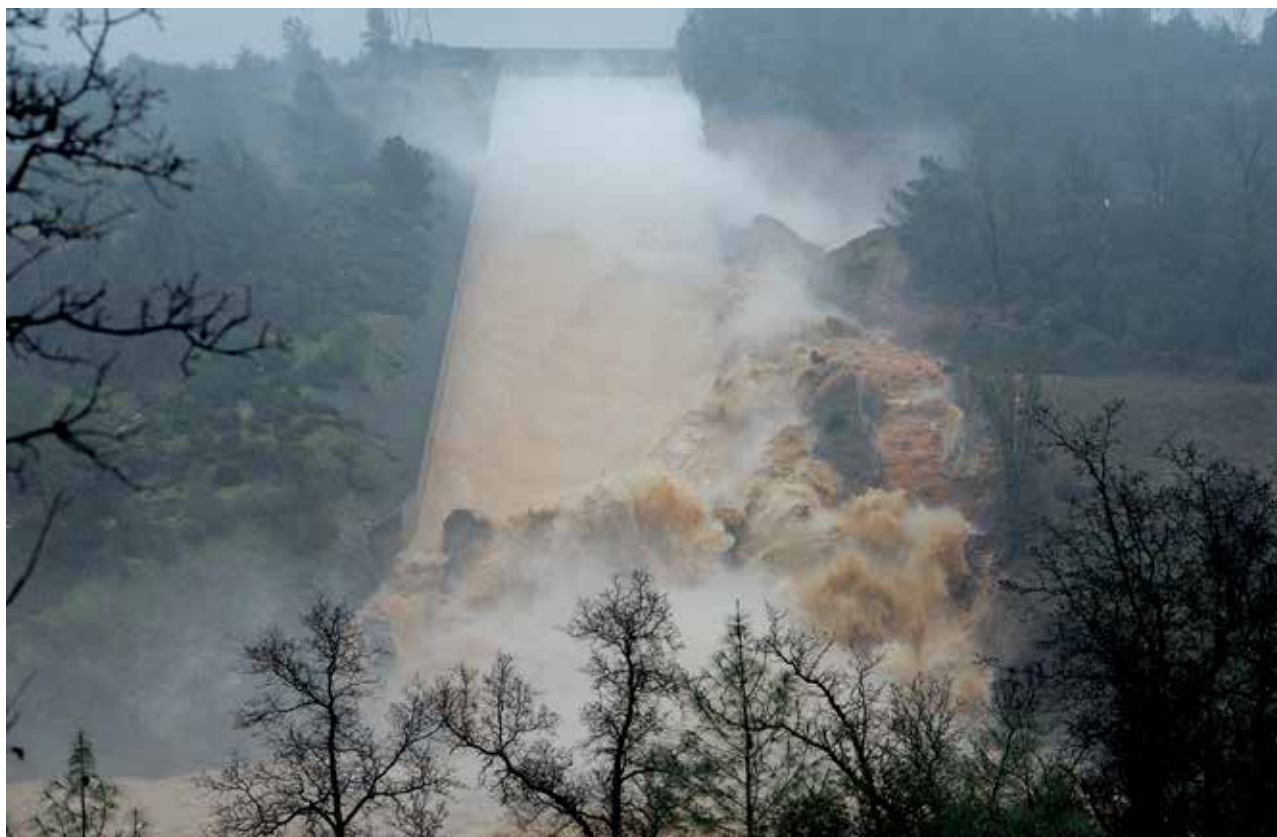
The Oroville Incident, Feb. 2017. As the Oroville Reservoir main spillway crumbles, mud, rocks and concrete flow in to the Feather River on February 8, 2017. *Source: Bill Husa, Chico Enterprise-Record.*

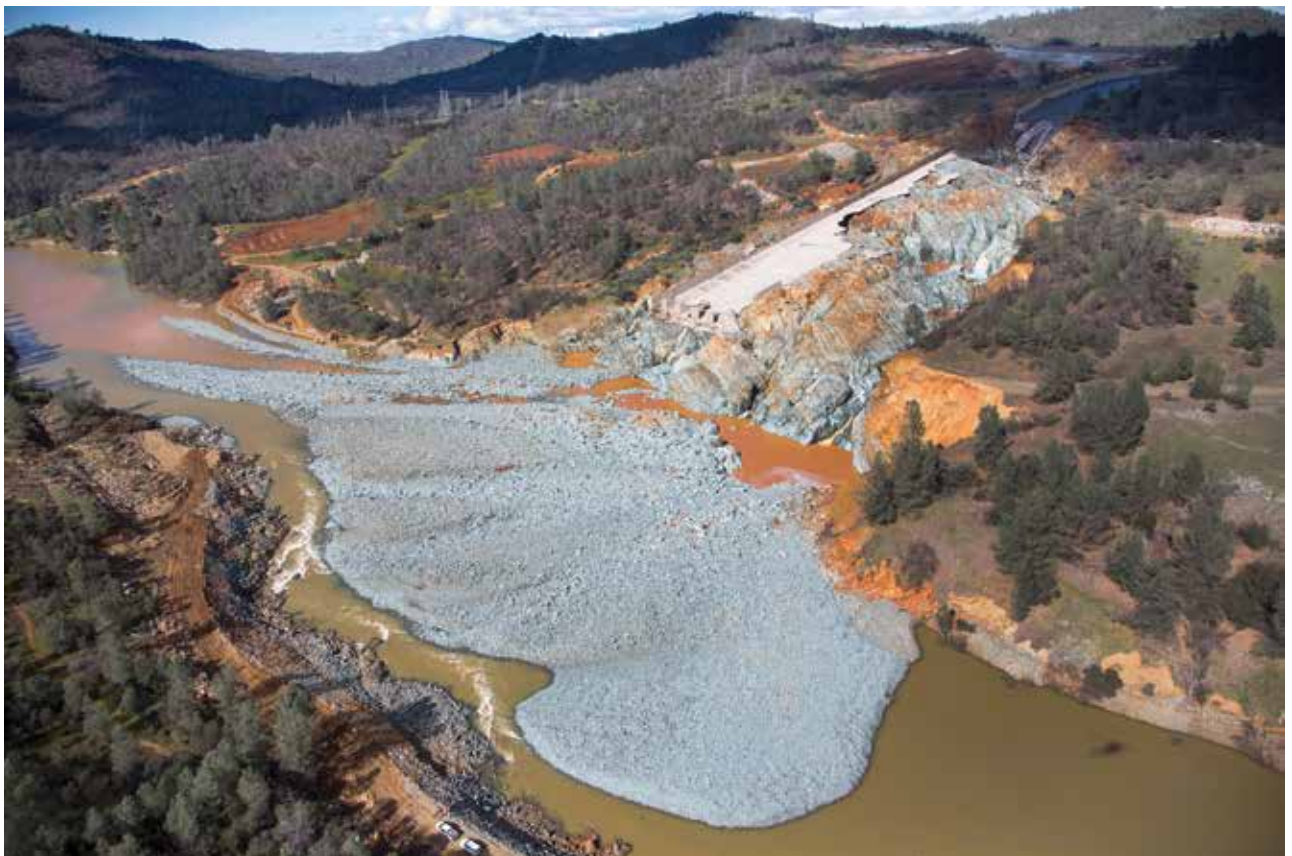
Damaged Main Spillway, Feb. 27, 2017. An aerial view of the damaged main spillway and resulting debris field. Flows were reduced from 50,000 cfs to zero on Feb. 27 to allow reduction of the water elevation in the diversion pool, removal of debris, and re-initiation of power generation at the Edward Hyatt powerhouse. *Source: Dale Kolke, DWR.*

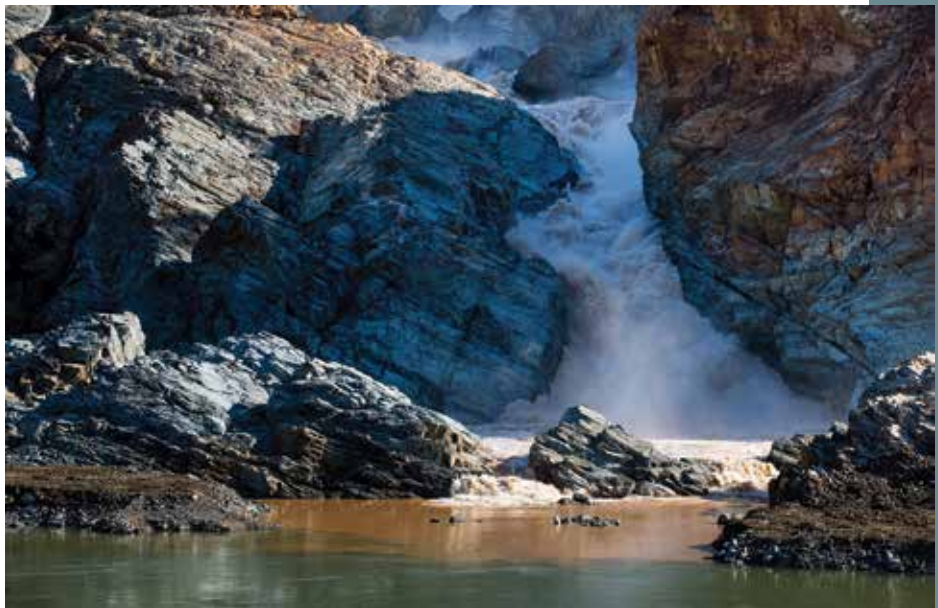
Flows leaving the damaged Oroville Main Spillway enter the diversion pool of the Feather River, April 14, 2017. Source: Kelly M. Grow, DWR.

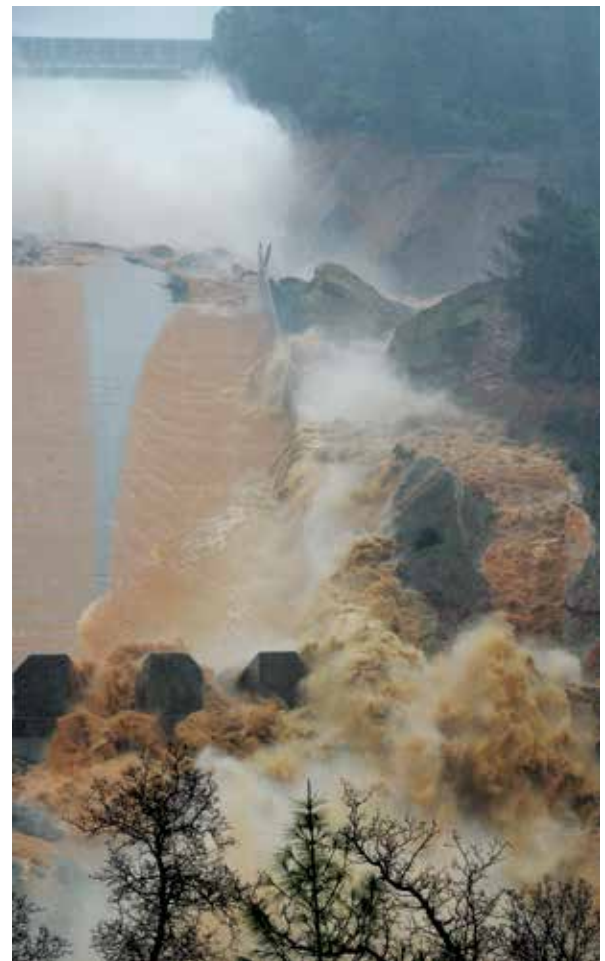
Damaged Oroville Main Spillway.
Mud and debris tumble down the newly eroded channel alongside the Oroville main spillway on Feb. 8, 2017.
Source: Bill Husa, Chico Enterprise-Record.
